**Arkansas Department of Environmental Quality  
Hazardous Waste Division  
Technical Branch  
Trip Report**

| <b>Project</b> | Former Cedar Chemical Facility |
| <b>Location</b> | West Helena, AR |
| <b>Reason</b> | Observe Site Conditions |

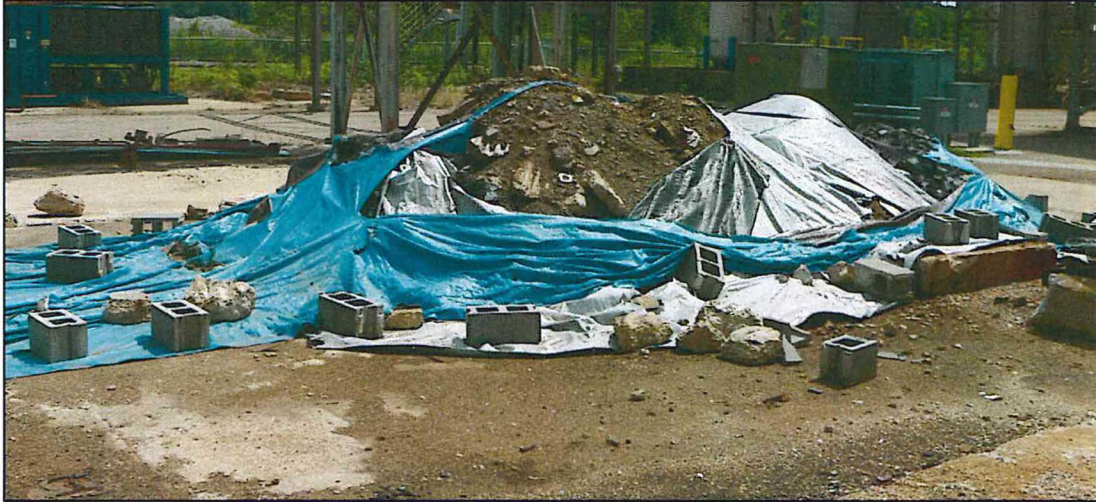
| <b>Photo # 1</b> | <b>Photographer:</b> Clay McDaniel, ADEQ <i>CM</i> |

| <b>Soil Pile from Sump Excavation</b><br>(located on the former Unit 4 footprint) | |

| <b>Action Items Summary</b> | <p>The soil pile from excavation of the sump is still located on the former Unit 4 foundation (see photo's 1 &amp; 2). It has been 519 days between when it was 1<sup>st</sup> discovered (ADEQ site visit on 3/1/2012) and this site visit. Bi-weekly status updates for the waste pile were requested in ADEQ letter dated 05/31/2012, but no updates have been submitted.</p> <p>Identified drum labeled hazardous waste (see photo # 3)</p> <p>The IDW (18 five-gallon buckets of purge water from the July 2010 sampling event, shown in photo #4) has not been disposed of. ADEQ letter dated 8/28/2012 provided procedures for proper disposal.</p> |

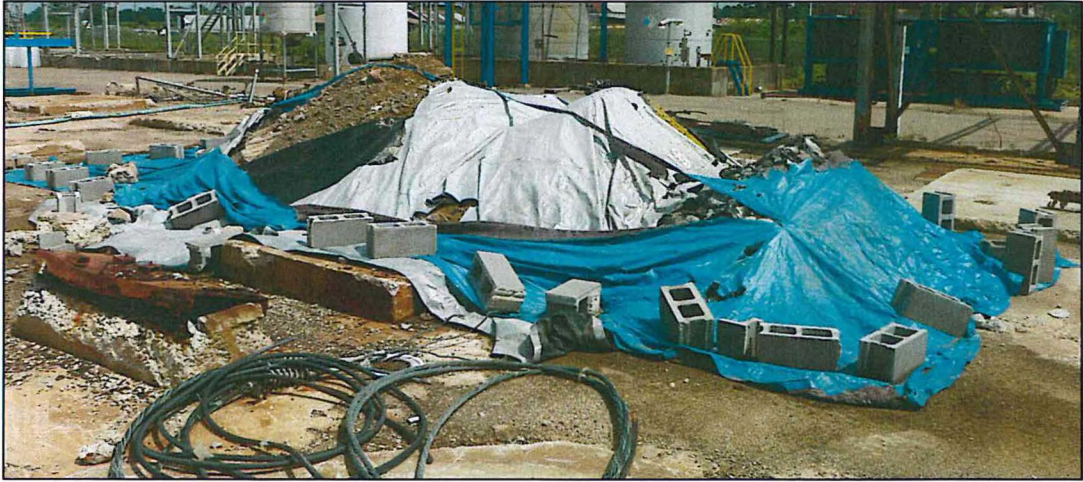
| <b>Photo # 2</b> | <b>Photographer:</b> Clay McDaniel, ADEQ <i>CM</i> |

| <b>Soil Pile from Sump Excavation</b> | |

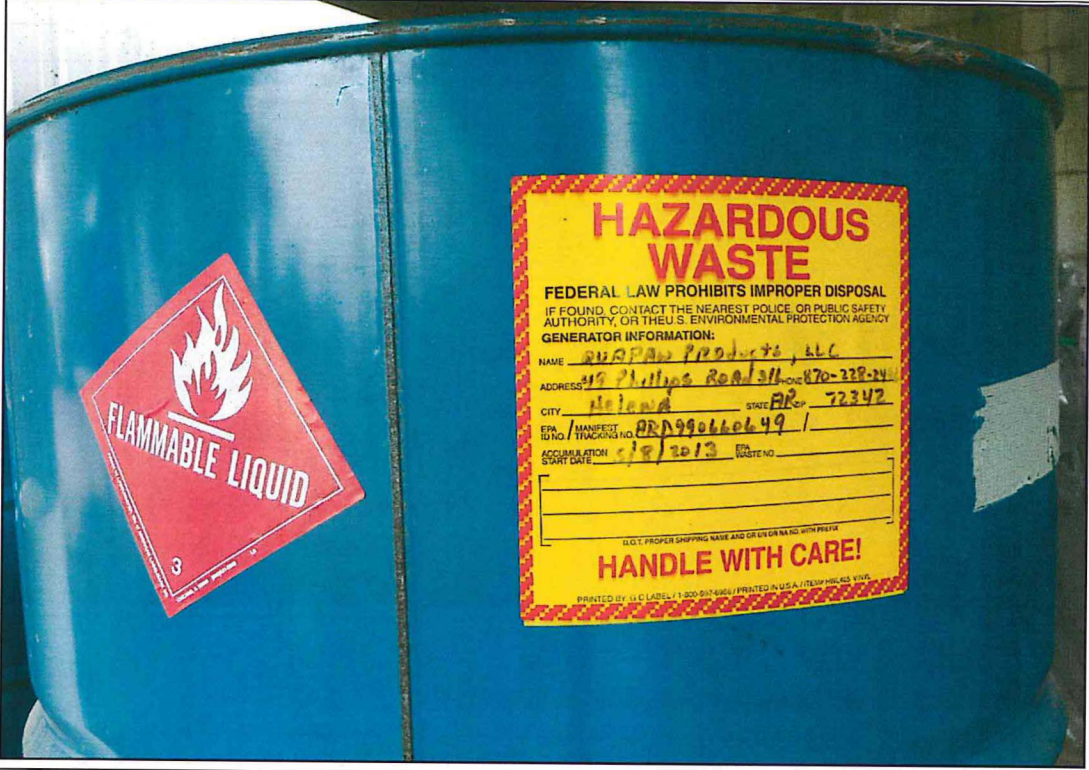
| <b>Photo # 3</b> | <b>Photographer:</b> Clay McDaniel, ADEQ <i>CM</i> |

| <b>55-Gallon Drum Labeled Hazardous Waste</b> | |

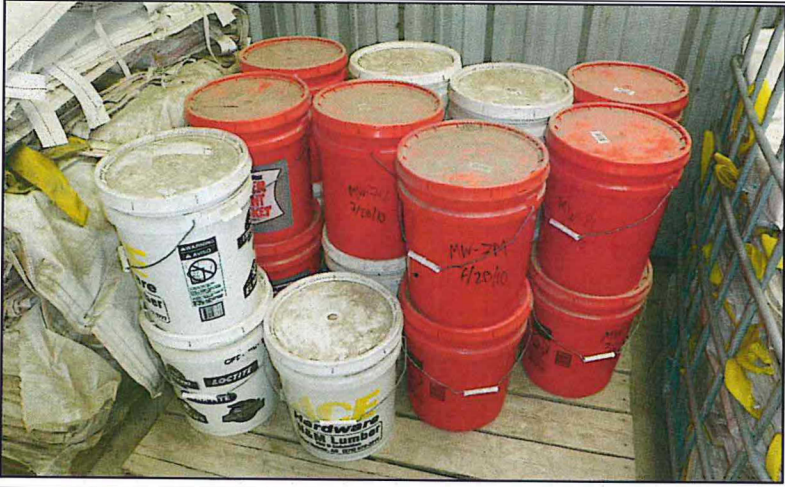
| <b>Photo # 4</b> | <b>Photographer:</b> Clay McDaniel, ADEQ <i>CM</i> |

| <b>Investigative Derived Waste (purged groundwater)</b> | |
